DEPARTMENT OF TRANSPORTATION

Contract #: 04-0120F4Cty: SF/ALA Rte: 80 PM: 13.2/13.9File #: 69.28**WELDING INSPECTION REPORT****Resident Engineer:**Pursell, Gary**Address:** 333 Burma Road**City:** Oakland, CA 94607**Report No:** WIR-001242**Date Inspected:** 15-Jan-2008**Project Name:** SAS Superstructure**OSM Arrival Time:** 630**Prime Contractor:** American Bridge/Fluor Enterprises, a JV**OSM Departure Time:** 1530**Contractor:** Zhenhua Port Machinery Company, Ltd (ZPMC), Changxing Island **Location:** Shanghai, China

Bridge No: 34-0006**Component:** Bay 2 and Bay 3 Observations**Summary of Items Observed:**

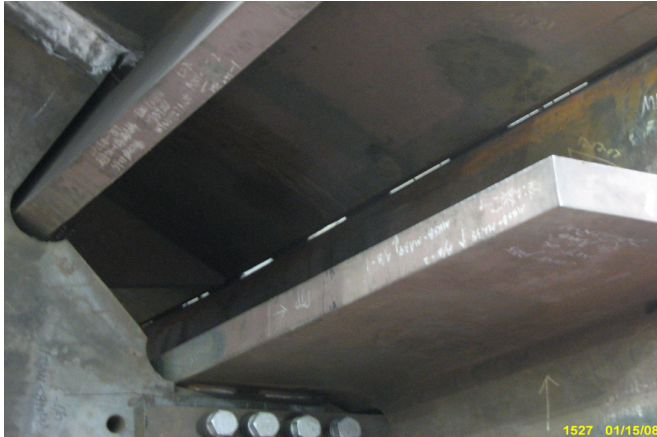
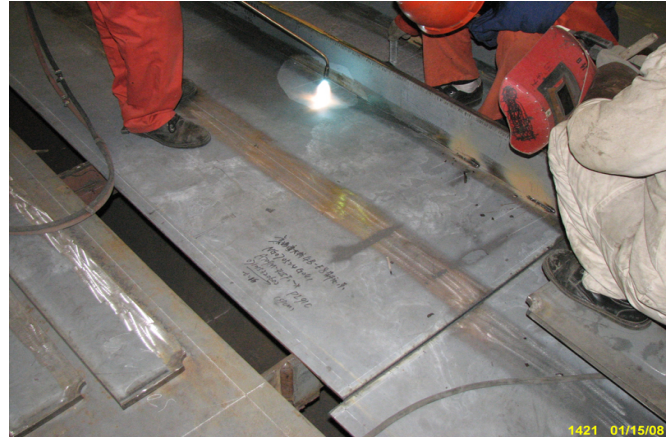
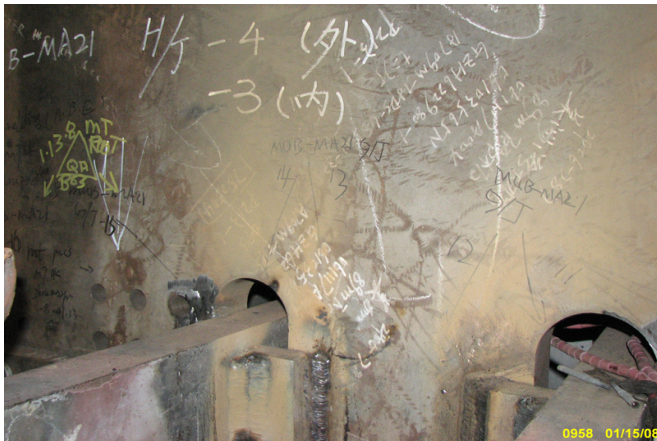
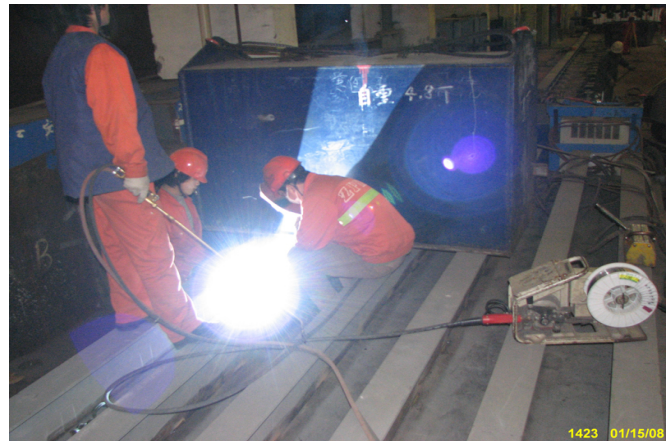
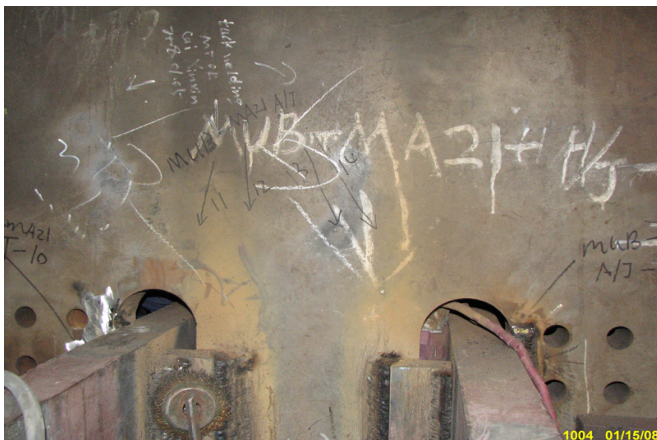
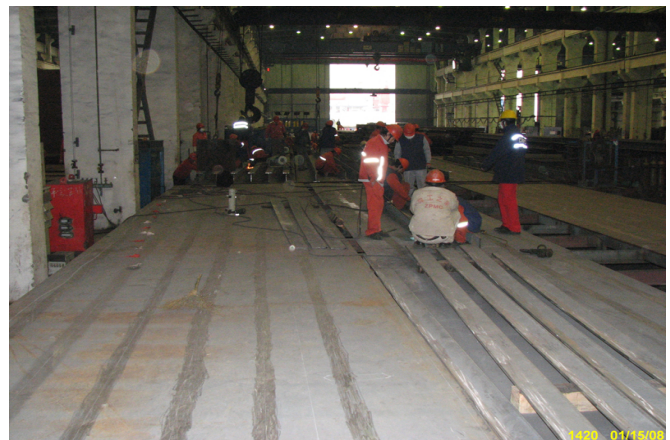
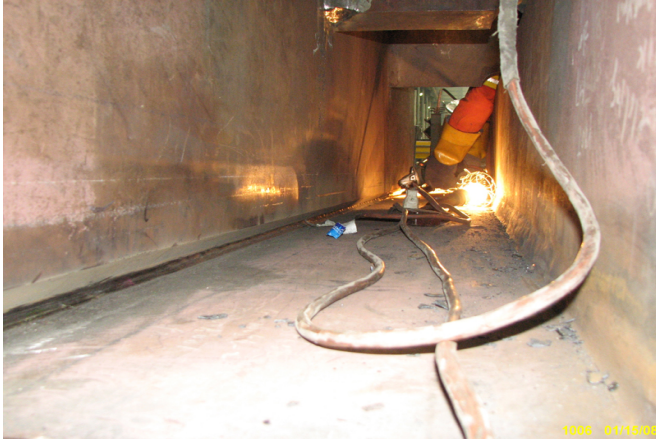
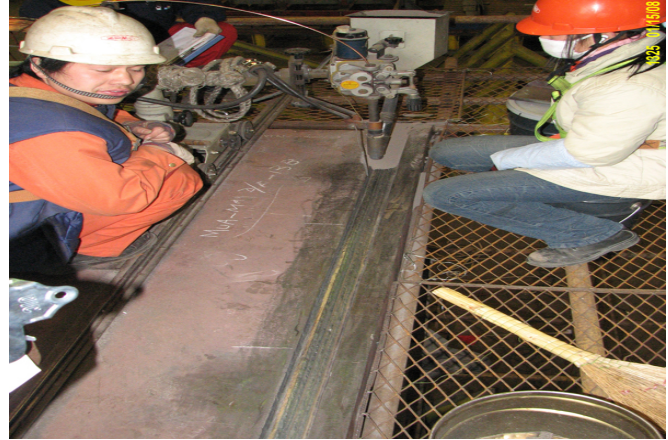
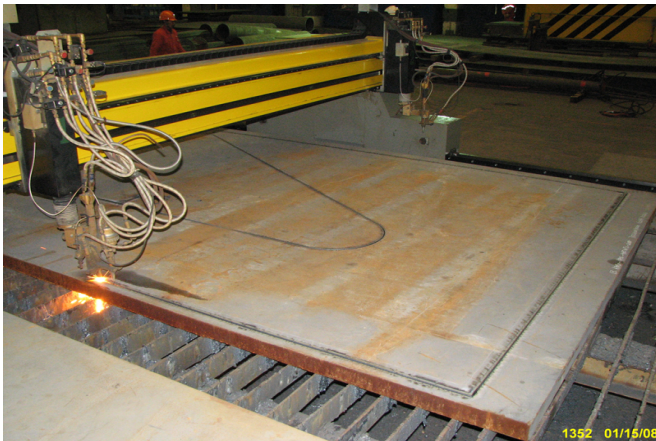
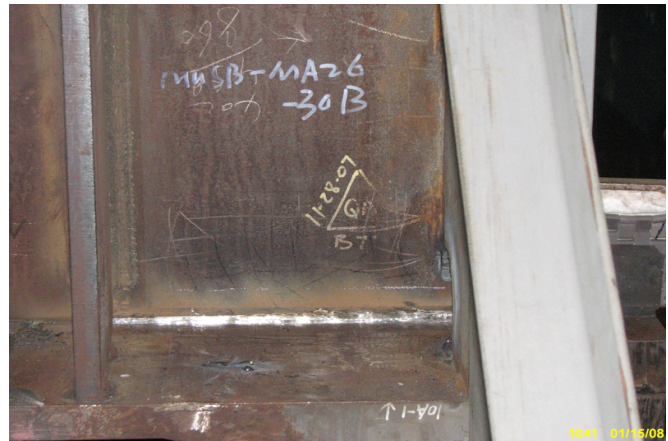
During the course of the Caltrans representative's surveillance, a gap (maximum 4.2mm) was noted in joint E/D. A smaller but visible gap was also noted in the D/C joint. No ladder was available for physical measurement. Three cracked root passes were noted for longitudinal stiffener to diaphragm attachment welds prior to this discovery (see observational report: January 13, 2008). Inference to this outcome indicates possible misalignment during transport. The Caltrans representative notified the field Bureau Veritas (BV) representative and the ZPMC CWI, Ye Yong Jun, of the findings. They, in turn, indicated that the joint needed to be further addressed. Further results are pending.

NOTE The Caltrans representative arrived on site, at 1400, to find Seismic Performance Critical Member (SPCM) thermal operations ongoing without a CWI being within visible or audible range. At 1407, the Caltrans representative notified Caltrans Task Leader, Mr. Robert Cuellar, of his findings and was instructed to perform

Included below are digital pictures that support the observations recorded within this report.
